VDGIF Project Review - Pond E Dredging at Possum Point Power Station

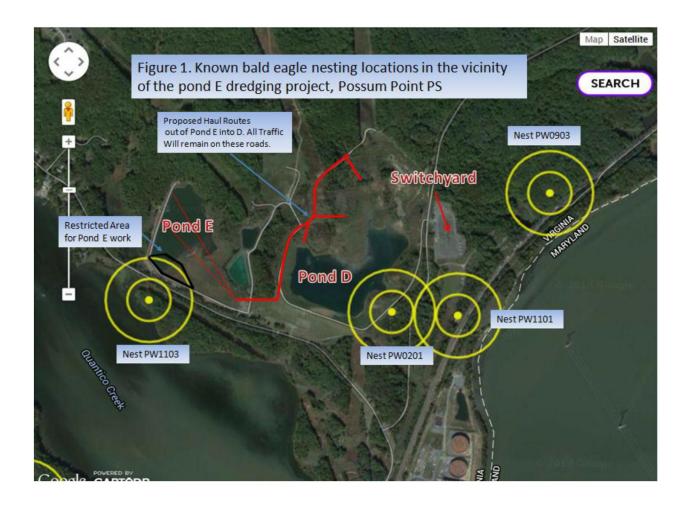
Figure 2. Location of bald eagle nest PW1103 as viewed from Pond E berm, $^{\sim}$ 420' away, 2/20/15.

Nest PW1103 – This nest is located on the Quantico Creek side of the site's entrance road, opposite pond E. Work activities within pond E will occur largely outside of the protective 660' buffer for this nest. A limited amount of dredging (~7% of the ponds acreage, ~14 days effort) will need to occur within the 660' buffer, but no closer than 420' to the nest. Topographically, a landscape buffer (~230' of forested ground) will remain intact on both sides of the entrance road between the work zone and the nest, thus limiting the potential visual impact (Figure 2). Work in the southwest corner of the pond

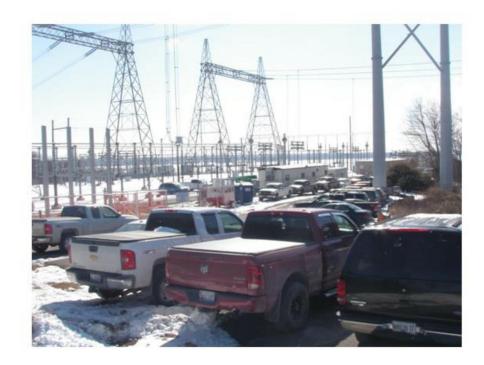
Figure 3. Possum Switchyard work activity north of bald eagle nests PW0201 and PW1101, 2/20/15.

- Conversion of the power station fuel source from coal to natural gas
- Seasonal increases in traffic and noise during outage maintenance work
- Upgrades and perimeter security enhancements to nearby switchyard equipment (current work site shown in Figure 3)
- Installation of fiber optic cable on site transmission structures
